HISTORY OF A FAULTY RETROFITTING: THE S. SEBASTIAN BRIDGE IN LOANO (ITALY)

F. Bonfiglietti¹, A. Brencich²

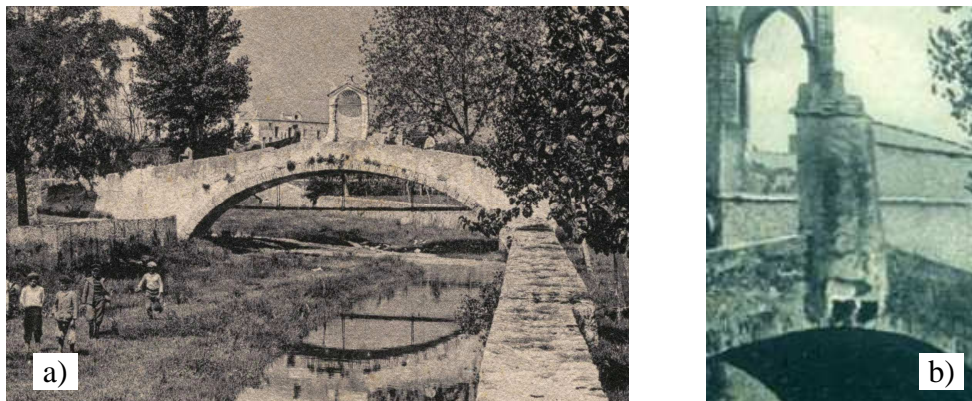
The bridge, crossing the Nimbalto stream 100m from the sea with a single span 14m long and 4m wide, connects the old city of Loano (west bank) to the east bank and was built between 1690 and 1691. A statue (of S. Sebastian, of course) in the aedicule, figure 1, was placed only in 1934 even though the aedicule was built on the northern side simultaneously to the bridge.

*Fig. 1 a) S. Sebastian bridge in a 1912 postcard. The black line below the bridge is the water pipe.
b) rear view of the aedicula.*

As figure 1 shows, the aedicule was supported by 3 cantilevers fixed in the barrel brickwork. Figure 6 shows the remains of the cantilevers after collapse outlining that the stones cracked but did not slide outside the arch, which means that no collapse of the cantilever restraints took place.

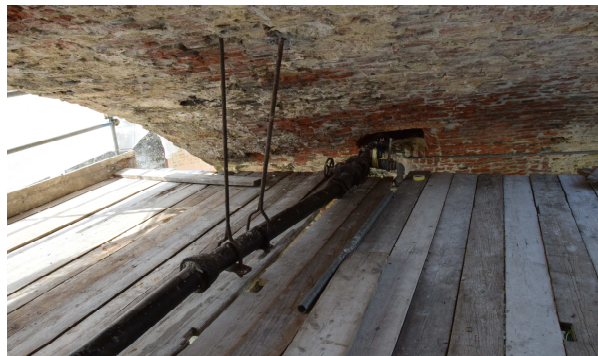
Fig. 2 Water pipe below the bridge – 2nd half of 19th century.

In the 2nd half of the 19th century a water pipe, figure 1, was placed below the bridge through a couple of holes in the arch barrel, figure 2. Around 1930, a gas pipe was placed below the pavement on the southern side; close to 1960 a concrete pavement (10cm thick) was placed over the old cobblestone, figure 3.

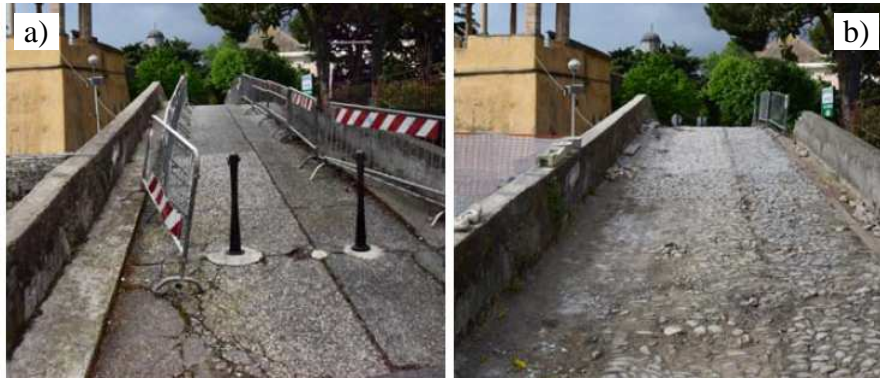
Fig. 3 a) Concrete pavement (1960 approx.). b) Original cobblestone on the right (after removal of the concrete layer). The southern side is on the left. On the right the „hole” in the spandrel due to the collapse of the aedicula

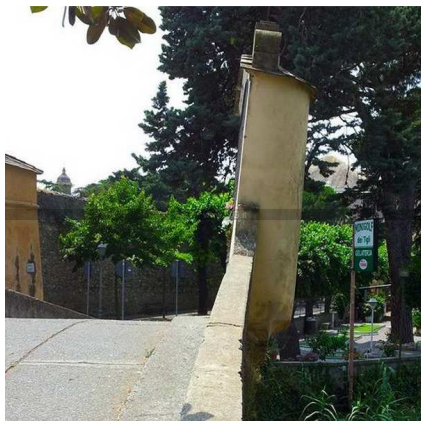
The 4th of July 2013 at 7PM, apparently with no reason (no wind, no impact, no load), the aedicule collapsed along with part of the armilla. Figure 4 shows its inclination few hours before the collapse. Figure 5 shows the collapsed armilla and the texture of the arch barrel.

Fig. 4 Few hours before the collapse.

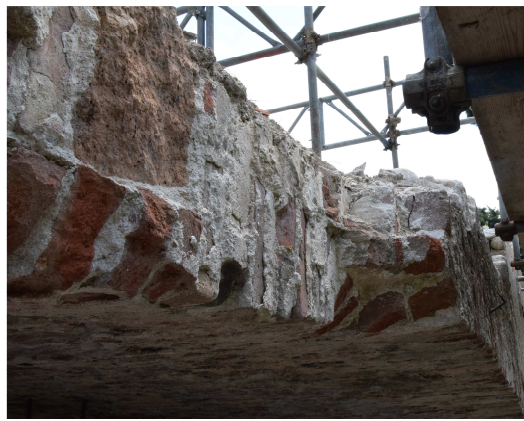
Fig. 5 Collapsed armilla on the northern side.

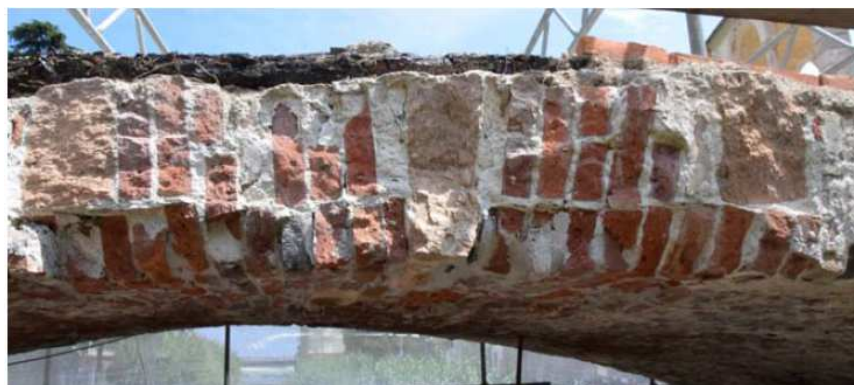
Fig. 6 Frontal view of the cracked surface.

B) the cantilevers were simply “substituted”: once removed the survived parts, figure 6, new cantilevers (same geometry of the ancient ones) were replaced in the arch barrel using expansive mortars to fix them in the arch. The armilla and the aedicule were later rebuilt using standard techniques. Such a procedure is uncertain since the removal of the survived parts of the cantilevers removes also the compressive stresses that guarantee the restraint to the cantilevers, figure 10.b. Besides, using the same material, the fatigue issue is not solved at all.

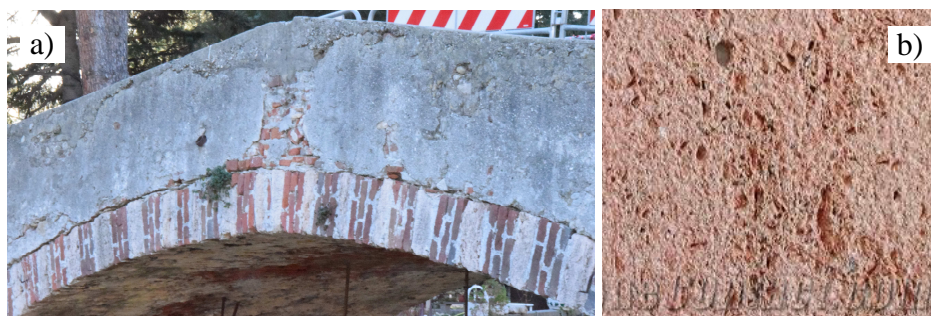
*Fig. 7 a) Spandrel on the south side: bad conditions and sliding (?) at the arch-spandrel interface;
b) texture of the Finale Stone (rose type).*

The spandrels were generally in bad conditions and sliding on the arch-spandrel interface appeared, figure 7.a.

The compressive strength of solid clay brickwork was assumed not lower than 5MPa. The *Finale* stone of the cantilevers is a local stone, highly inhomogeneous, figure 7.b, exhibiting low and highly variable mechanical properties: $f_t = 3\text{-}8\text{MPa}$ and $f_c = 23\text{-}64\text{MPa}$.
